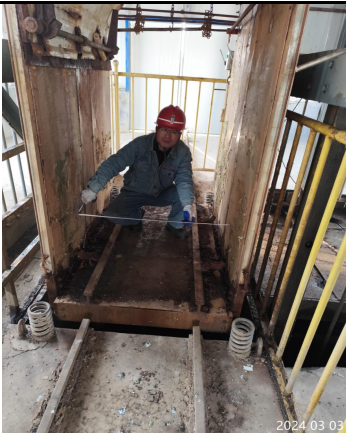
| 序号 | 报告编号 | 发布日期 | 结论 | 影像资料 |
|---|---|---|---|---|
| 43 | GX-B1380/20-6-24001 | 2024/3/20 | 所检项目合格。 | A worker in a red helmet and blue jacket is kneeling on a metal platform inside a tunnel, measuring a horizontal distance with a tape measure. The tunnel walls are lined with wooden planks, and there are some pipes and equipment visible in the background. The timestamp "2024 03 03" is visible in the bottom right corner of the image. |

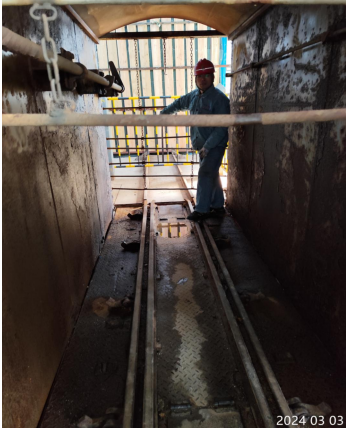
| 序号 | 报告编号 | 发布日期 | 结论 | 影像资料 |
|---|---|---|---|---|
| 44 | GX-B1380/20-6-24002 | 2024/3/20 | 所检项目合格。 | A worker in a red helmet and blue jacket is standing on a metal platform inside a tunnel, measuring a horizontal distance with a tape measure. The tunnel walls are lined with wooden planks, and there are some pipes and equipment visible in the background. The timestamp "2024 03 03" is visible in the bottom right corner of the image. |

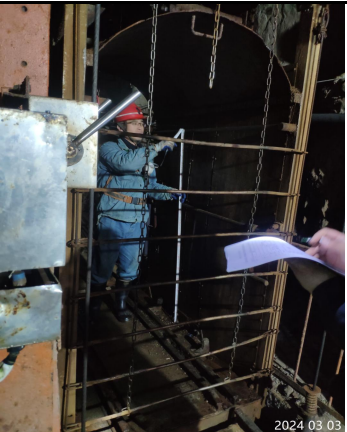
| 45 | GX-B1380/20-6-24003 | 2024/3/20 | 所检项目合格。 | |

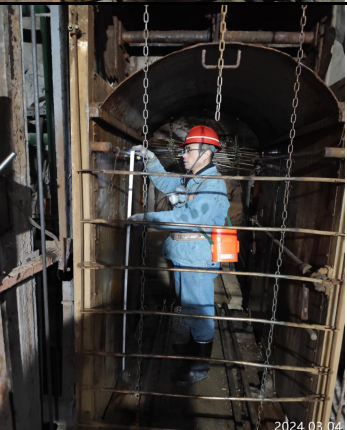
| 46 | GX-B1380/20-6-24004 | 2024/3/20 | 所检项目合格。 | |

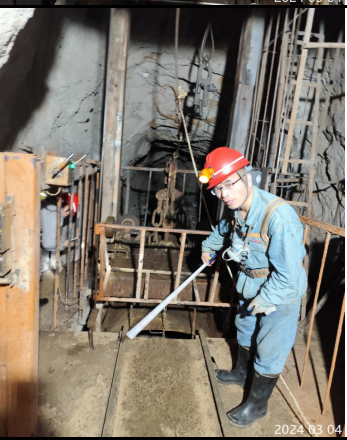
| 47 | GX-B1380/20-6-24005 | 2024/3/20 | 所检项目合格。 | |

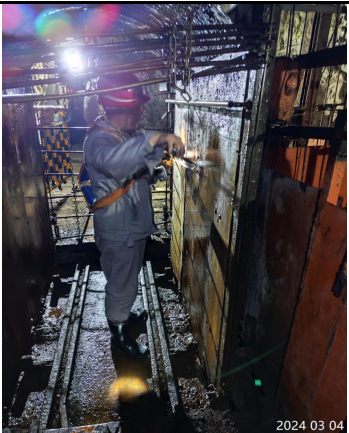
| 48 | GX-B1380/20-6-24006 | 2024/3/20 | 所检项目合格。 | <p>2024 03 04</p> |

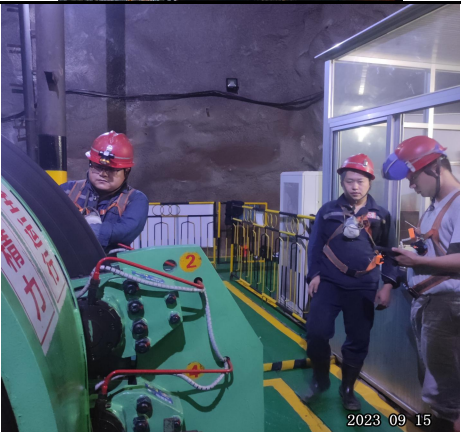
| 49 | GX-B1304/21-6-24001 | 2024/3/20 | 所检项目合格。 | <p>2023 09 15</p> |

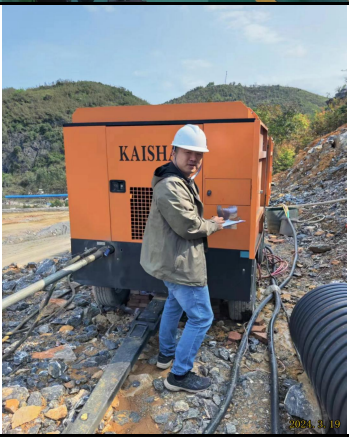
| 50 | GX-B1520/20-6-24023 | 2024/3/21 | 综合判定：合格。 | <p>2024 03 21</p> |

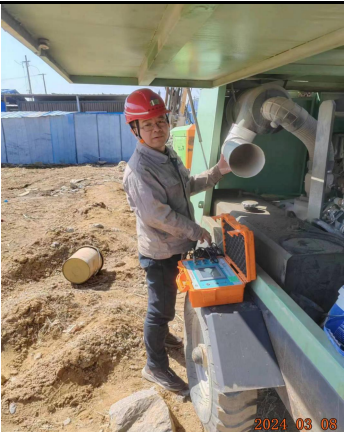
| 51 | GX-B1520/20-6-24019 | 2024/3/15 | 综合判定合格 | |

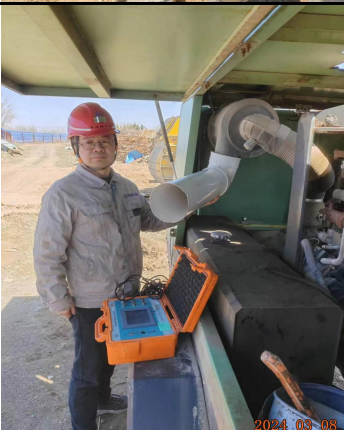
| 52 | GX-B1520/20-6-24020 | 2024/3/15 | 综合判定合格 | |

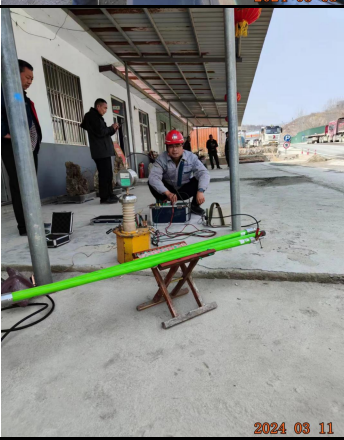
| 53 | GX-B1328/20-6-24036 | 2024/3/15 | 所检项目合格 | |

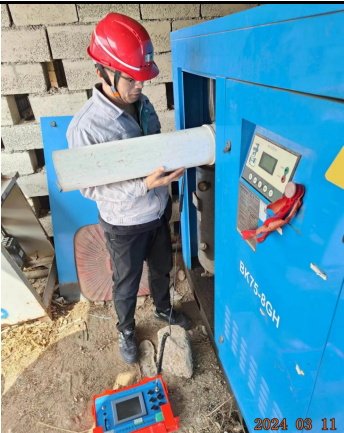
| 54 | GX-B1307/20-6-24006 | 2024/3/14 | 综合判定合格 | |

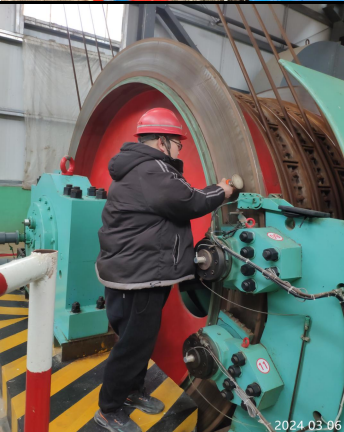
| 55 | GX-B1304/21-6-24003 | 2024/3/19 | 综合判定：合格。 | |

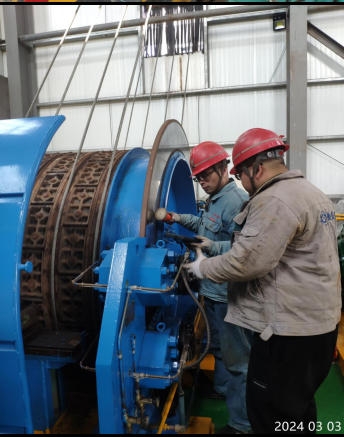
| 56 | GX-B1304/21-6-24002 | 2024/3/19 | 综合判定：合格。 | |

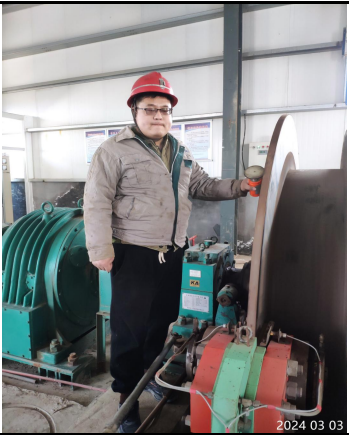
| 57 | GX-B1303/21-6-24005 | 2024/3/19 | 综合判定：合格。 | |

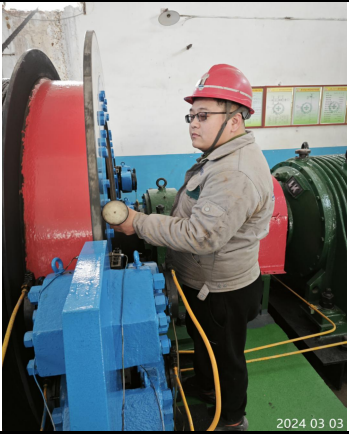
| 58 | GX-B1303/21-6-24006 | 2024/3/19 | 综合判定：合格。 | |

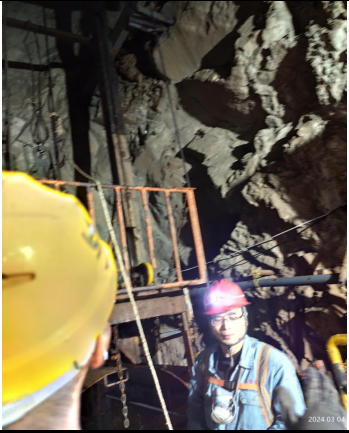
| 59 | GX-B1303/21-6-24007 | 2024/3/19 | 综合判定：合格。 | |

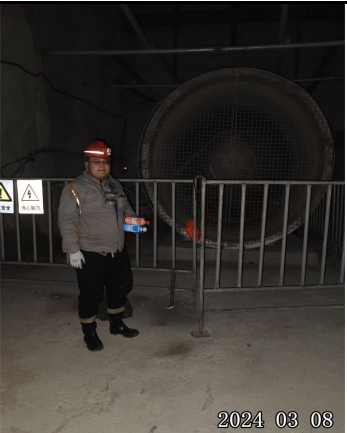
| 60 | GX-B1428/21-6-24003 | 2024/3/21 | 无缺陷迹痕显示 | |

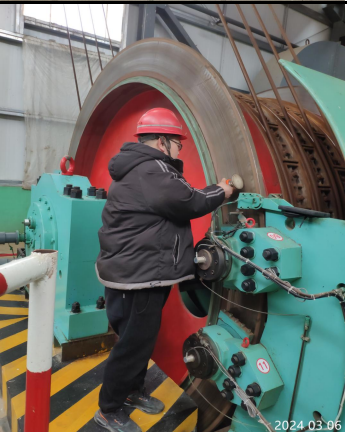
| 61 | GX-B1304/21-6-24003 | 2024/3/19 | 综合判定：合格。 | |

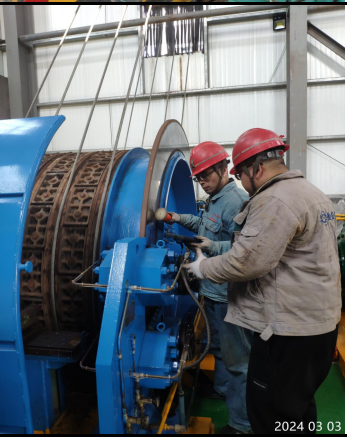
| 62 | GX-B1304/21-6-24002 | 2024/3/19 | 综合判定：合格。 | |

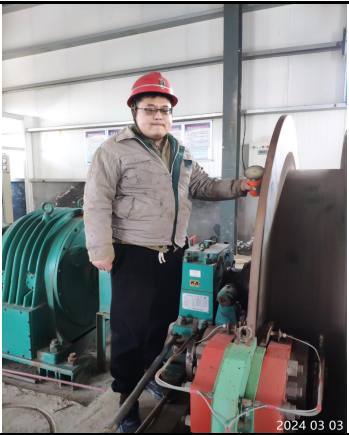
| 63 | GX-B1303/21-6-24005 | 2024/3/19 | 综合判定：合格。 | |

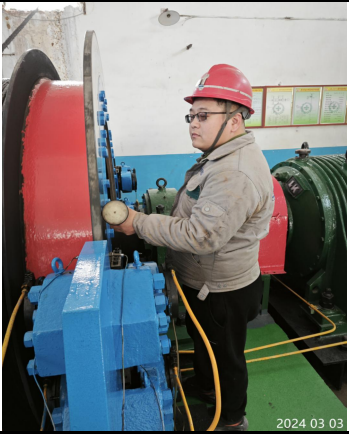
| 64 | GX-B1303/21-6-24006 | 2024/3/19 | 综合判定：合格。 | |

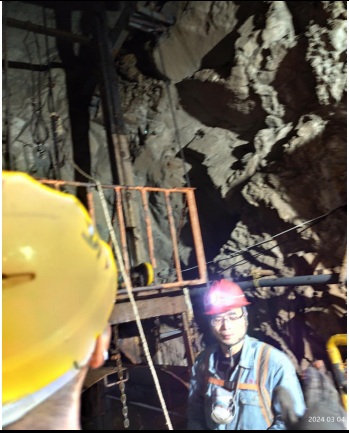
| 65 | GX-B1303/21-6-24007 | 2024/3/19 | 综合判定：合格。 | |

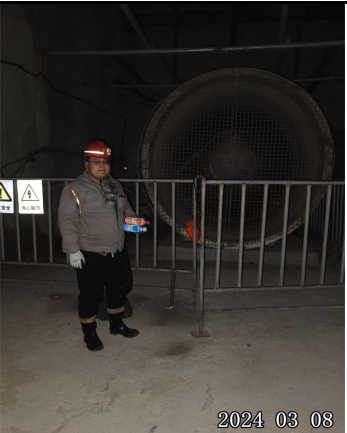
| 66 | GX-B1428/21-6-24003 | 2024/3/21 | 无缺陷迹痕显示 | | | |

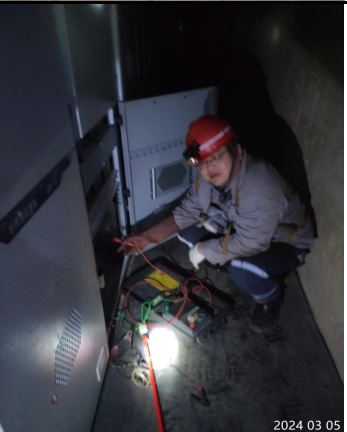
| 67 | GX-B1322/21-6-24013~24024 | 2024/3/20 | 所检项目合格 | | | |

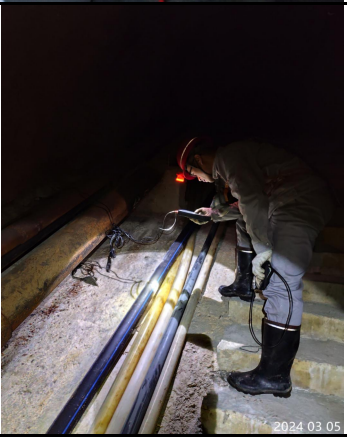
| 68 | GX-B1309/21-6-24001 | 2024/3/20 | 所检项目合格 | | | |

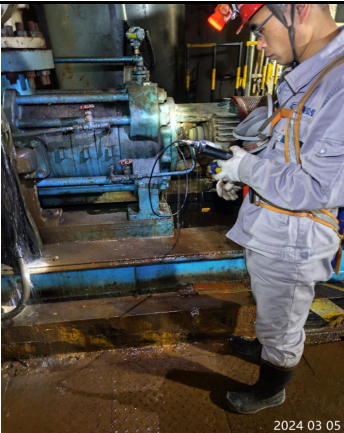
| 69 | GX-B1500/21-6-24003 | 2024/3/20 | 综合判定合格 | <br>2024 03 05 | |

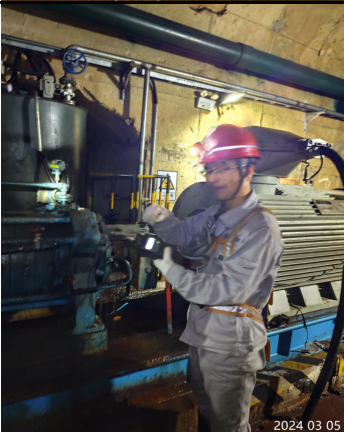
| 70 | GX-B1500/21-6-24004 | 2024/3/20 | 综合判定合格 | <br>2024 03 05 | |

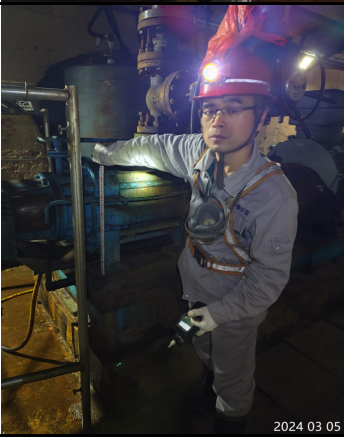
| 71 | GX-B1500/21-6-24005 | 2024/3/20 | 综合判定合格 | <br>2024 03 05 | |

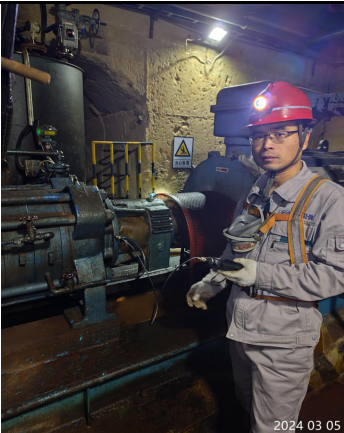
| 72 | GX-B1500/21-6-24006 | 2024/3/20 | 综合判定合格 | | |

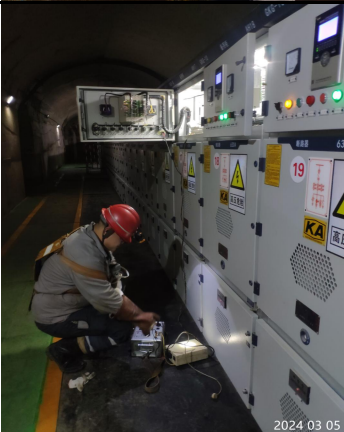
| 73 | GX-B1451/20-6-24036~24053 | 2024/3/20 | 所检项目合格 | | |

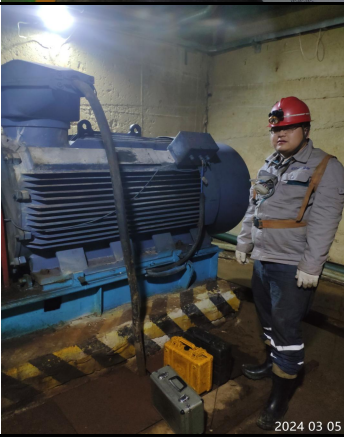
| 74 | GX-B1324/21-6-24006~24009 | 2024/3/20 | 所检项目合格 | | |

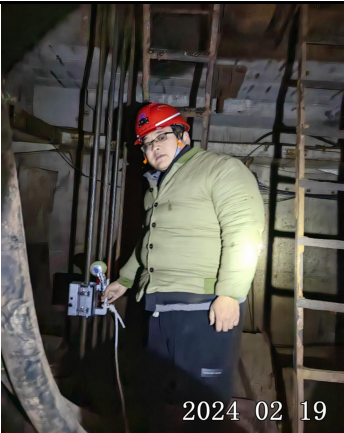
| 75 | GX-B1598/21-6-24017 | 2024/3/18 | 实测钢丝绳有效截面<br>积损失百分比最大为<br>4.27%，小于5%为正常。 | |

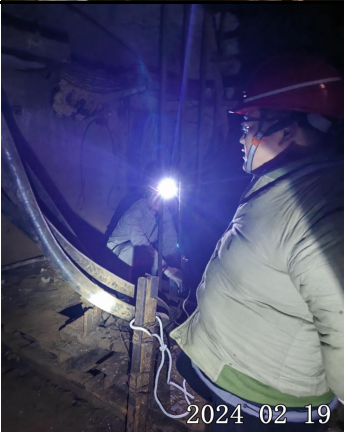
| 76 | GX-B1598/21-6-24018 | 2024/3/18 | 实测钢丝绳有效截面<br>积损失百分比最大为<br>3.78%，小于5%为正常。 | |

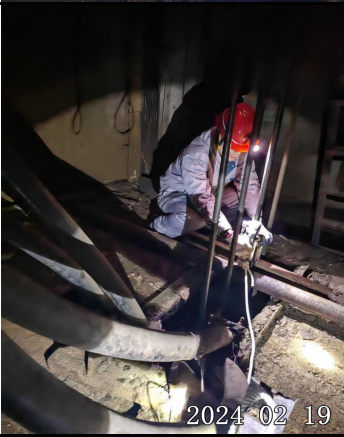
| 77 | GX-B1598/21-6-24019 | 2024/3/18 | 实测钢丝绳有效截面<br>积损失百分比最大为<br>3.80%，小于5%为正常。 | |

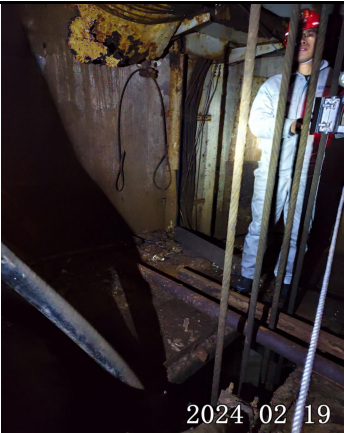
| 78 | GX-B1598/21-6-24020 | 2024/3/18 | 实测钢丝绳有效截面积损失百分比最大为3.73%，小于5%为正常。 | |

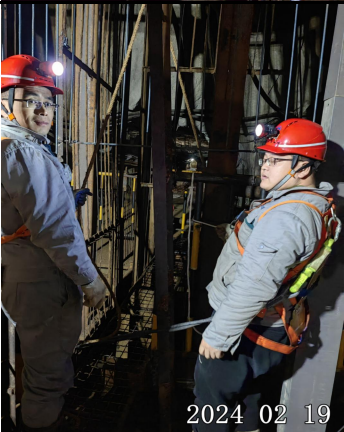
| 79 | GX-B1598/21-6-24021 | 2024/3/18 | 实测钢丝绳有效截面积损失百分比最大为3.25%，小于5%为正常。 | |

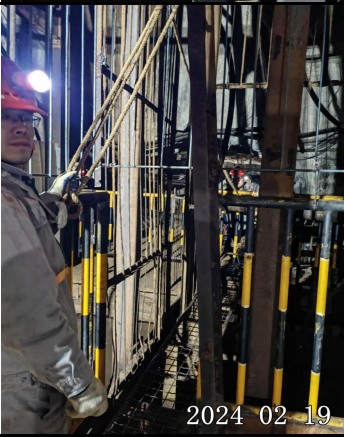
| 80 | GX-B1598/21-6-24022 | 2024/3/18 | 实测钢丝绳有效截面积损失百分比最大为3.87%，小于5%为正常。 | |

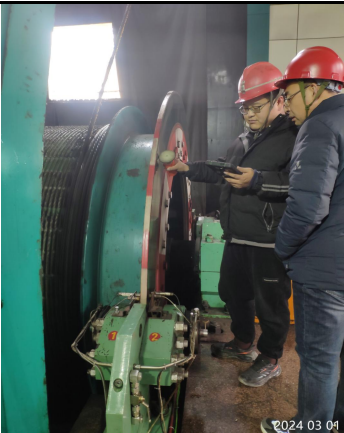
| 81 | GX-B1300/20-6-24002 | 2024/3/18 | 综合判定合格 | |

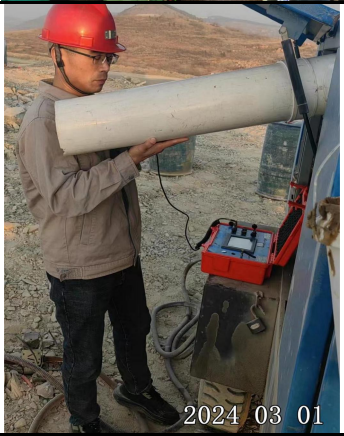
| 82 | GX-B1520/20-6-24018 | 2024/3/18 | 综合判定合格 | |
